Manhole Inspection Summary

Manhole # S27G__024MH

Location Address: **11 S :Poppleton St**

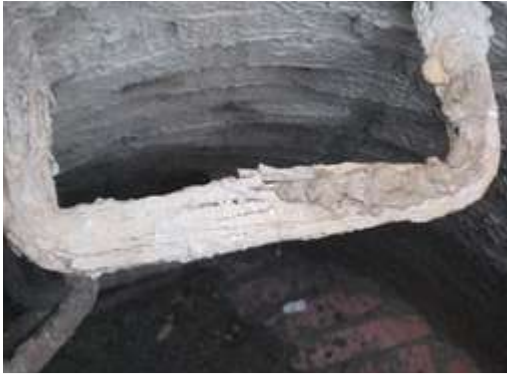
Defect 3

Count: **4** Missing: **0** ☒ **Corroded**

corroded rung

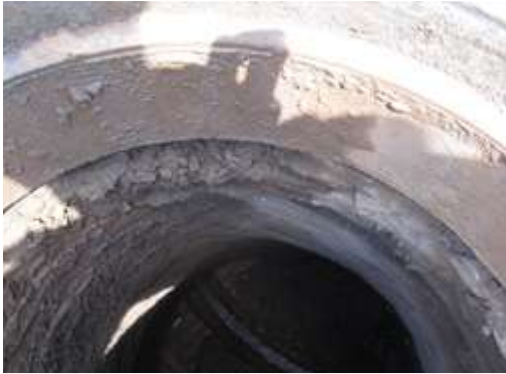
Defect 4

Offset: **1.5** (in.)

Frame offset

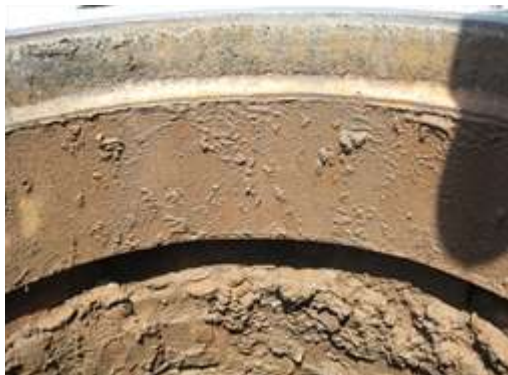
Defect 2

Condition: ☐ Sound ☐ Cracked ☒ **Leaks**

frame leaks, infiltration frame lid connect

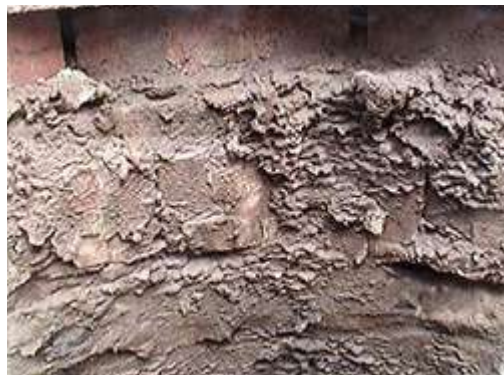
Defect 1

Condition: ☐ Sound ☐ Cracked ☐ Root Intrusion ☒ **Loose Brick** ☐ Deteriorated

Infiltration: ☐ None ☒ **Joint** ☐ Cracks ☒ **Mortar** ☐ Roots ☐ Wall

infiltration at chimney ,mortar missing

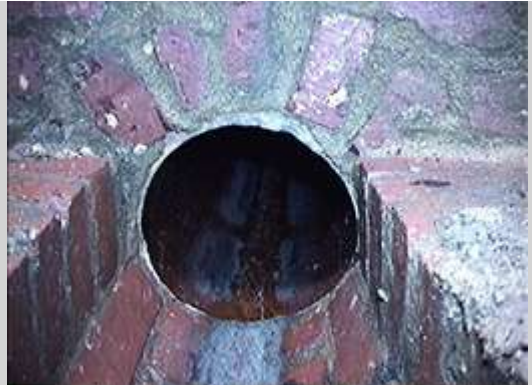
12 O'Clock Outflow

Pipe Height: **8.4** (in.) Rod and Bar (Angled)
Pipe Material: **Clay** ☐ Pipe Lined
Invert Depth: **9.48** (ft.) Flow Characteristics: **Fast**
Deposits: ☒ None ☐ Mud ☐ Sludge ☐ Debris ☐ Grease
Silt Depth: **0** (in.) Deposits Extent:
Infiltration: **None** Pipe Seal Cond: **Sound**

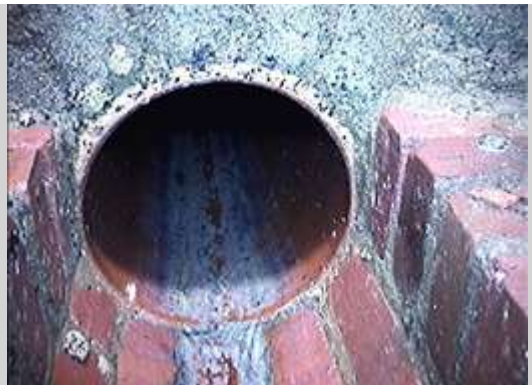
5 O'Clock Inflow

Pipe Height: **8.4** (in.) Rod and Bar (Angled)
Pipe Material: **Clay** ☐ Pipe Lined
Invert Depth: **9.11** (ft.) Flow Characteristics: **Fast**
Deposits: ☒ None ☐ Mud ☐ Sludge ☐ Debris ☐ Grease
Silt Depth: **0** (in.) Deposits Extent:
Infiltration: **None** Pipe Seal Cond: **Sound**
